Autumn Investigation: Progress Report

V 2.4
02 May 2019

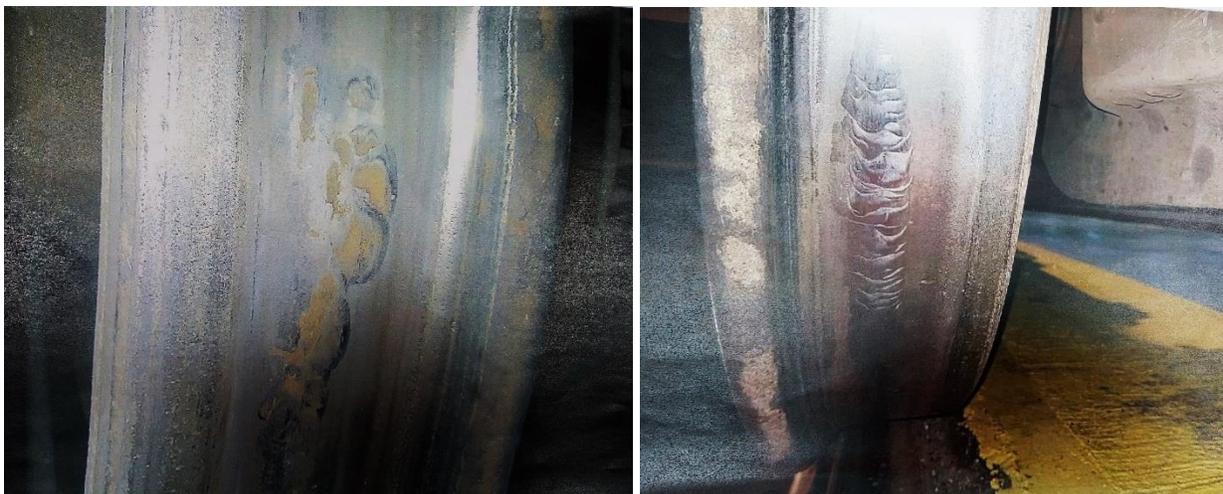
Wheel flats, examples of which are shown in Figure 1, are a form of wheel damage resulting from wheel slip or slide against the railhead. This occurs where the coefficient of friction between wheel and rail is insufficient to maintain the adhesion required for the desired traction/ braking force. As the wheelset ceases to roll freely, either rolling more slowly than the rest or locking completely, a flat develops on the wheel tread and control of the train is momentarily lost. Once present, a wheel flat is noticeable by the banging sound as the wheel rotates. This is accompanied by an increase in vertical wheel-rail forces which can damage the vehicle and track if not addressed.

Figure 1: Examples of severe wheel flats from November 2018.

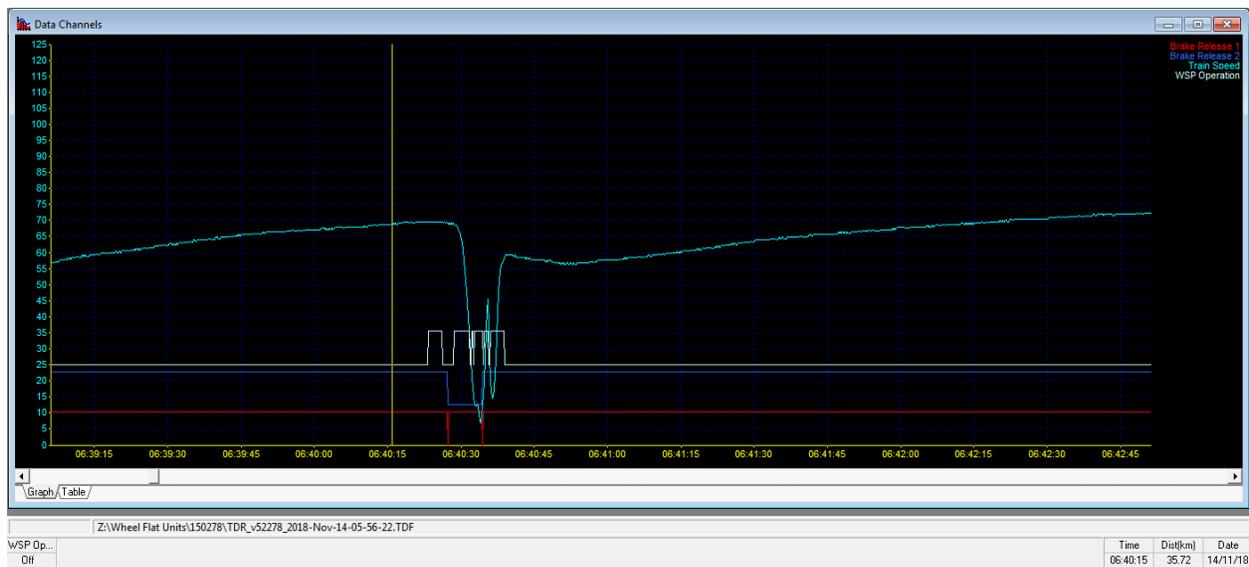
- Analysis of the on-train monitoring and recording (OTMR) downloads, taken from units stopped with wheel flats, revealed that in some cases running brake tests were carried out using brake step 2 from the start, rather than using a controlled increase through step 1, as shown in *Figure 4* below. This practice originated from ambiguity in the drivers’ braking instructions, which included actions no longer required by the rulebook. As a result, the instructions are to be updated, to apply the brakes more gradually on tread-braked units without WSP.

Figure 4: Example of a class 150 OTMR download showing a wheel slide at 70 mph. Speed (blue) drops rapidly towards zero following a brake application indicating that the wheelset is locked whilst the train continues moving.

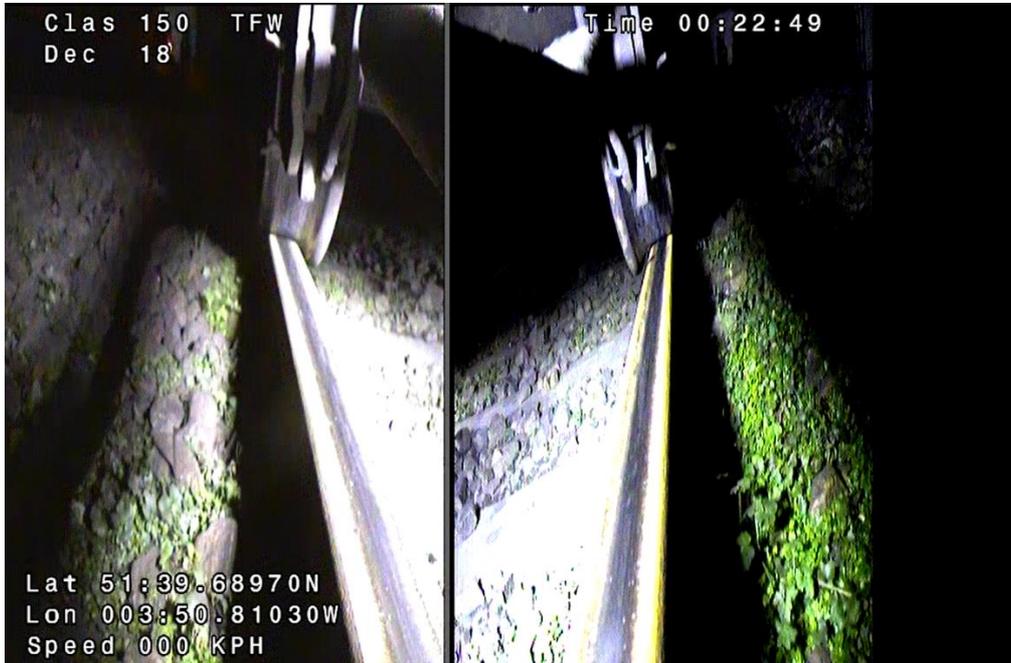
Foliage on the ballast at Skewen down platform.

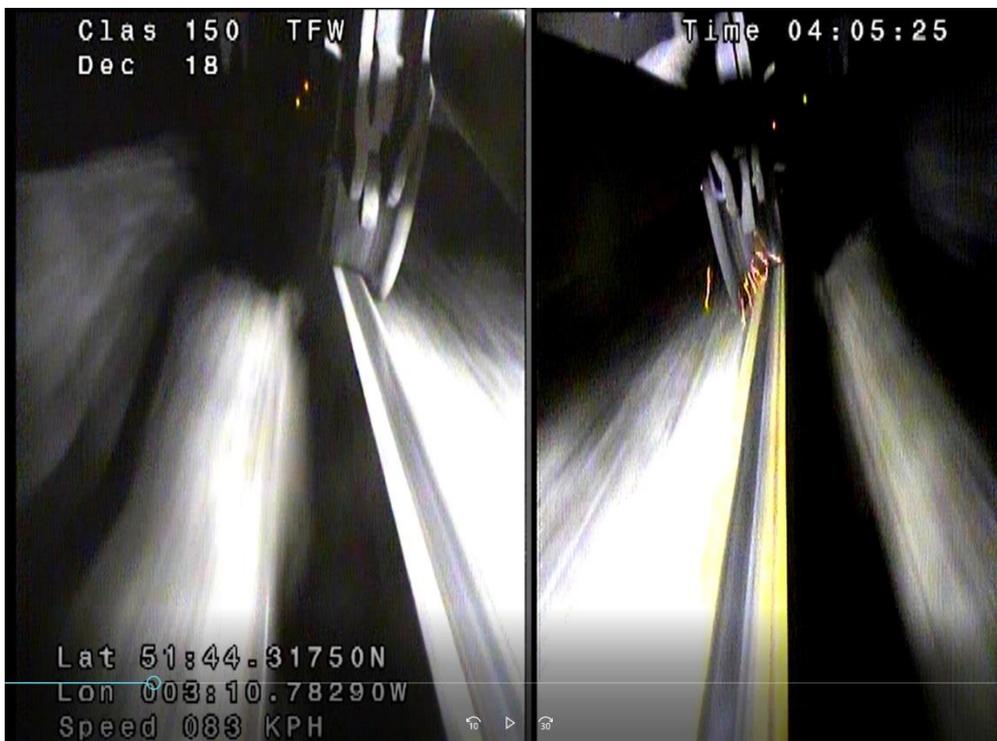
Metal swarf visible when braking, down approach to Llanhilleth.

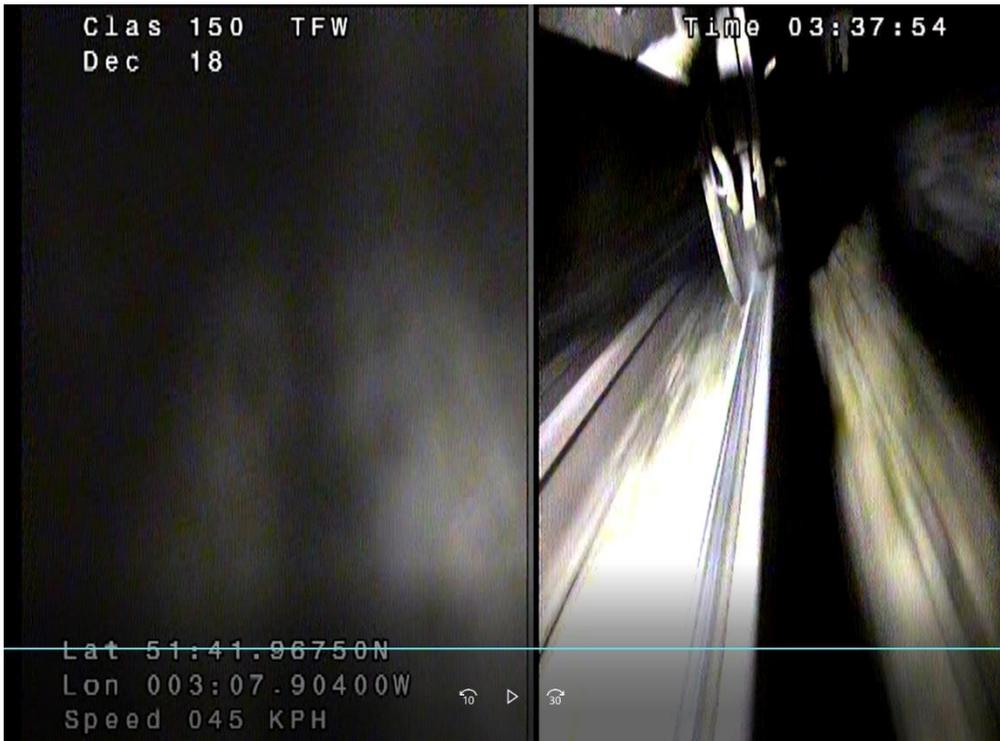
Wheel slide, up approach to Llanhilleth.

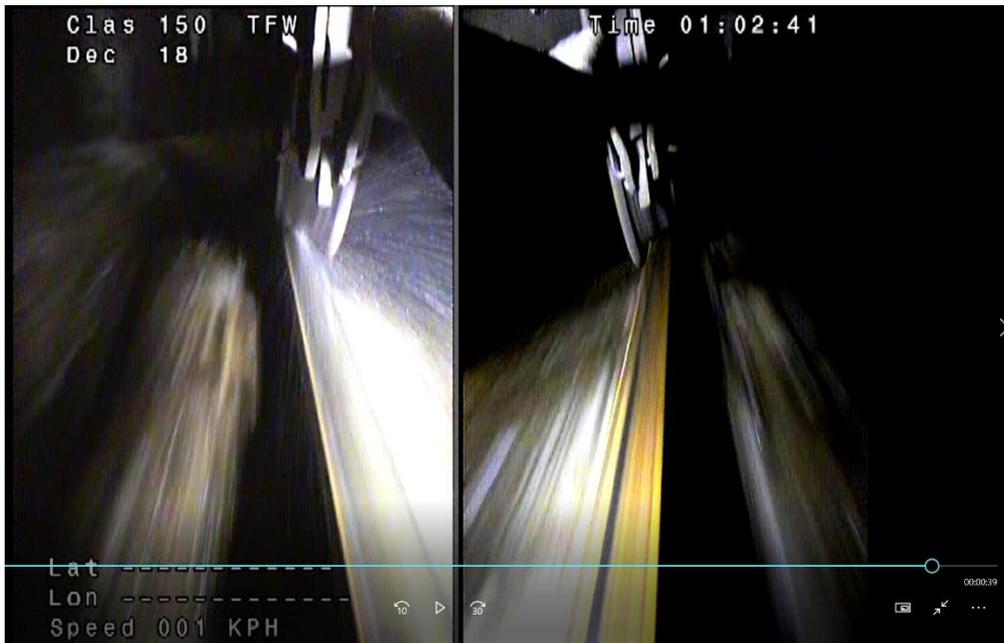
Water on railhead, Cockett tunnel down.

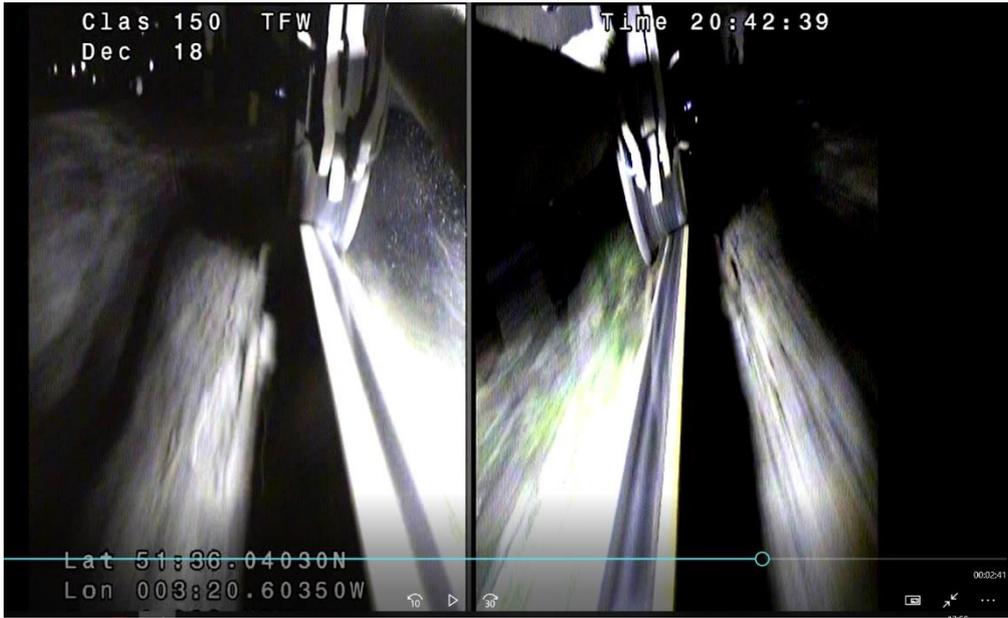
Dust expelled from wheel-rail interface, up direction beyond Pontypridd station.
