Autumn Investigation: Progress Report

V 2.4
02 May 2019

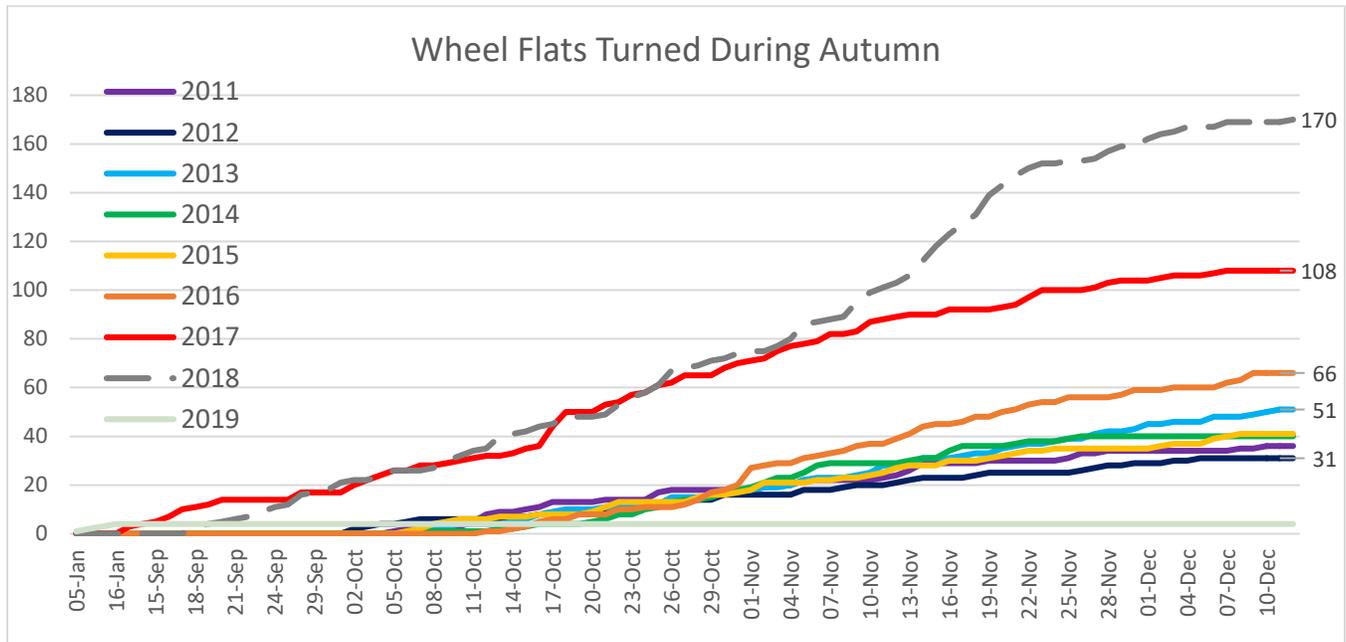
Figure 2: Units stopped for tyre turning each autumn – running total by date.

As shown in Figure 2, the number of wheel flats encountered by the TfW fleets has grown in the last 2-3 years. Autumn 2017 saw an unprecedented increase against 2016, which was exceeded again by over 50% during 2018. At the worst point in mid-November 2018, over a quarter of the TfW fleet was stopped awaiting the wheel lathe or wheelset changes.

It can be seen that the rate of wheel flats decreased after the end of November, with only occasional flats found during December and into January 2019.

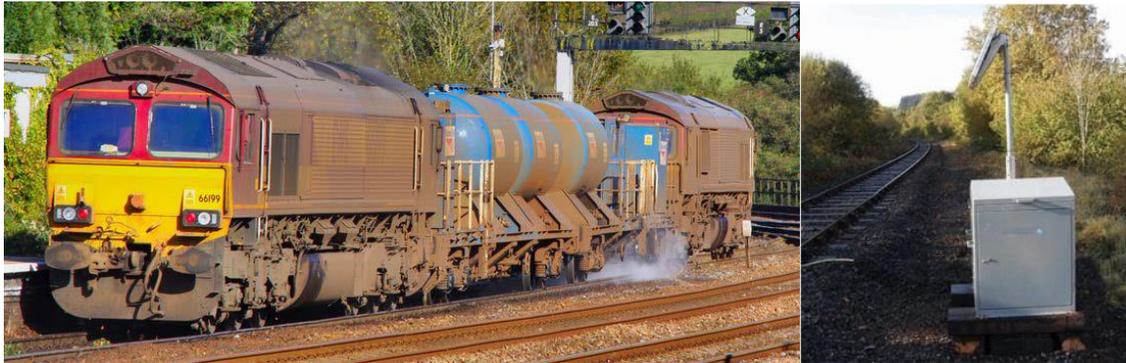
Figure 3: (a) Railhead treatment train (b) Traction gel applicator.

- Railhead treatment train (RHTT) diagrams were planned, which for 2018 included 2 daily treatments of the Rhymney valley line. RHTTs began running on 1st October which was after the start of the low adhesion period as seen in Figure 1.

- Traction gel applicators (TGAs) were deployed at a number of locations and some upgraded for 2018. These lineside devices dispense a gel containing sandite onto the railhead at intervals determined by the passing of trains. Despite annual review, their positioning around the network has remained largely unchanged for several years.

- NR conducted a trial of the gel’s carry-down distance in April 2017, finding that the gel is only in contact once per wheel revolution and extends around 50 metres beyond the applicator. It is also noted that gel may be consumed, or nozzles may become blocked, before the 2-week inspection/ replenishment cycle. Their limitations mean that their presence could be causing drivers to overestimate the adhesion conditions and brake harder as a result.

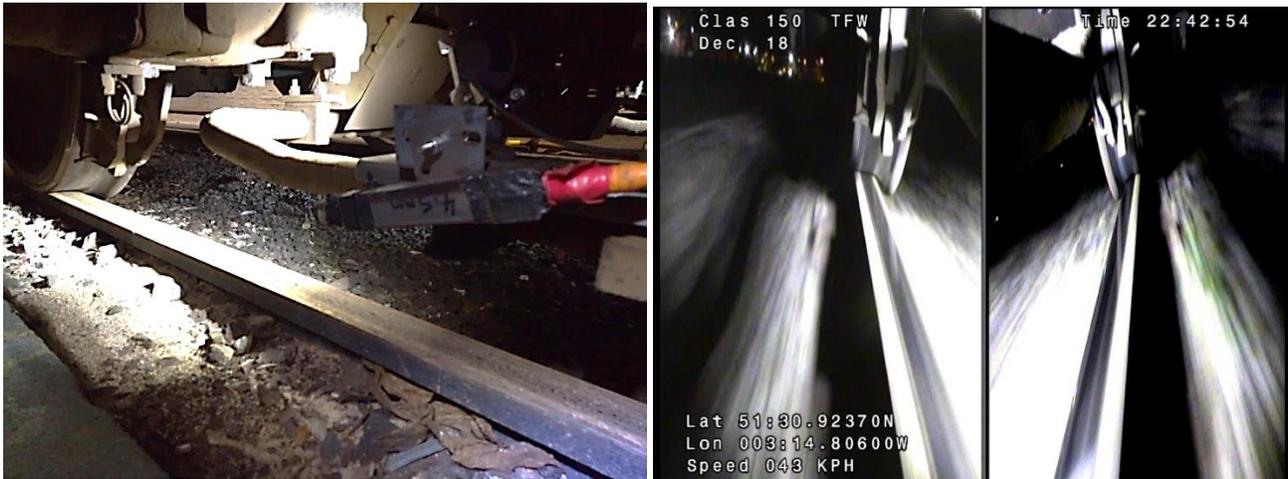
Figure 5: Equipment fitted to the underframe and picture from camera.

Fitting cameras to the underframe of trains, along with GPS to monitor the trains’ speed and location, gives the ability to capture the curving and braking behaviour of wheelsets. This approach aims to localise any issues involving wheel and rail profiles, as well as help identify areas with contaminants (either vegetation or external sources) which could be affecting adhesion.

Following the initial meeting, the engineering change process was completed to allow fitment of the cameras to trains running as empty coaching stock (ECS) in traffic during the night. A class 150 unit was used to cover as much of the network as reasonably practical and because '150s had seen an increase in wheel flats in-line with other fleets.

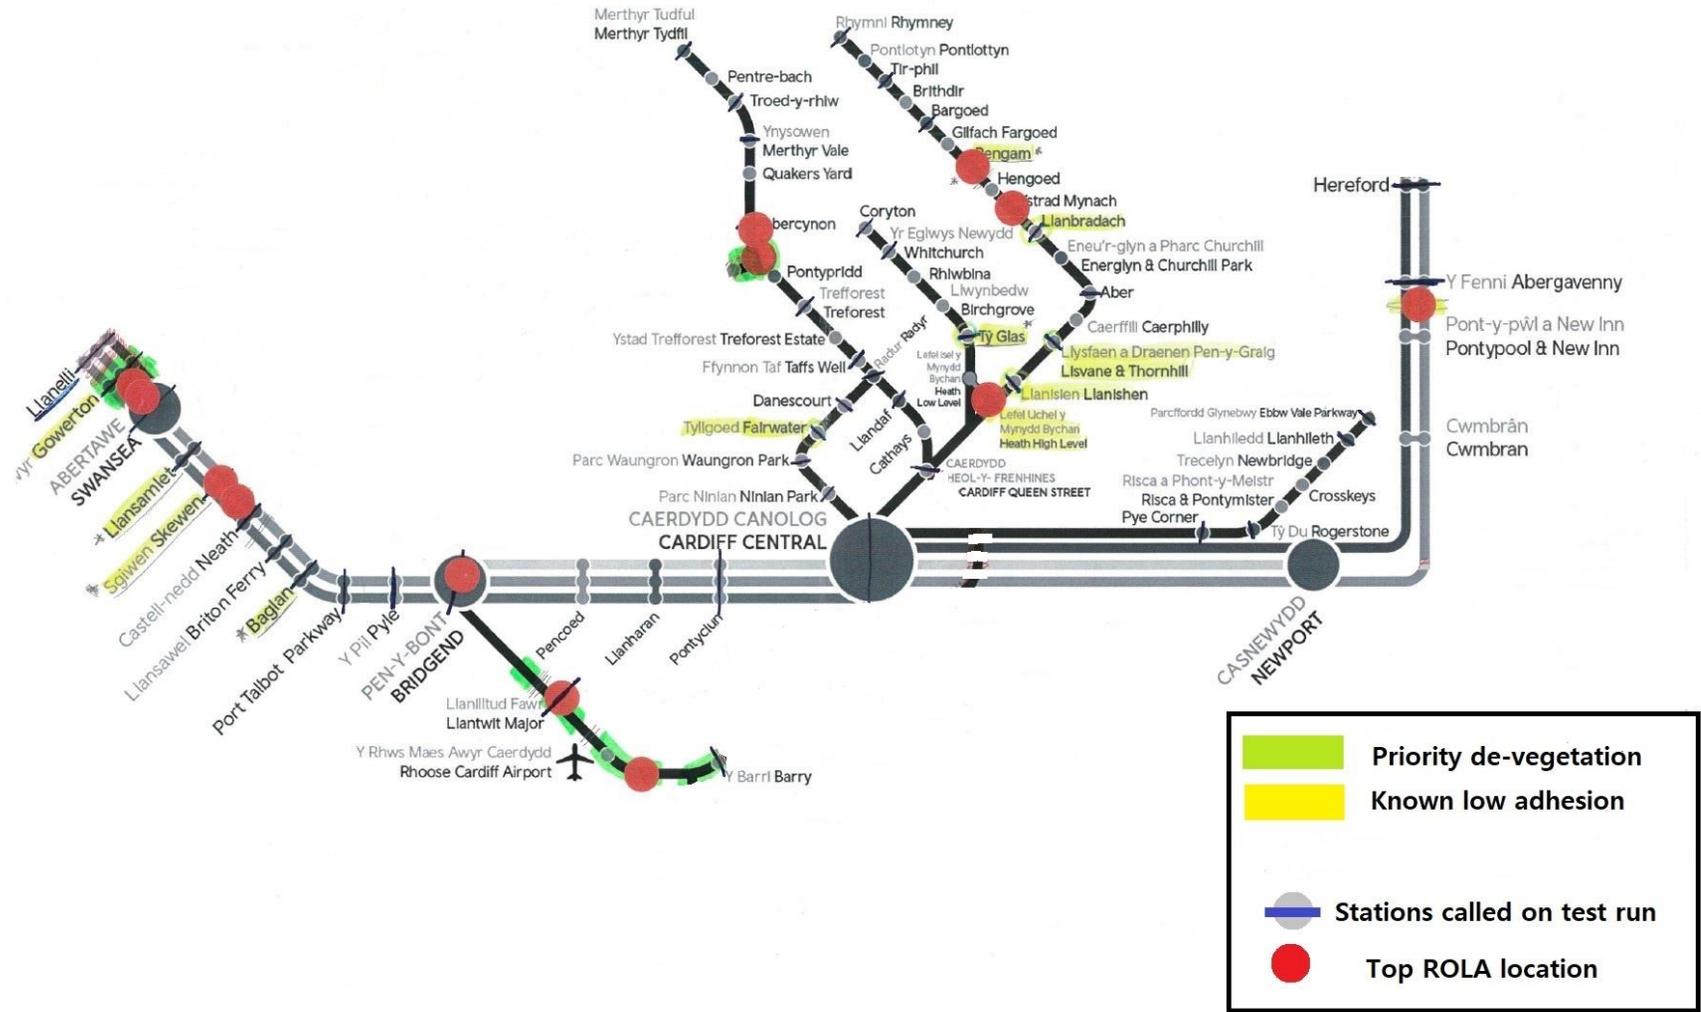
Routes covered by the camera test runs, showing sites with known low adhesion, priority vegetation management and more than 2 records of low adhesion (ROLAs) submitted.
