1. Introduction

The Transport For Wales (TFW) fleet experienced a high number of wheel flats during November 2018 resulting in an excessive number of units being taken out of service. To investigate the root cause, TFW have appointed Metropolitan Railway Consultants Ltd (MRCL), a specialist in wheel-rail interface to work with the TFW Rail Services engineering team and Network Rail. The objective of the investigation is to identify the root cause, and recommend short- and long-term measures to minimise the risk of flats being developed.

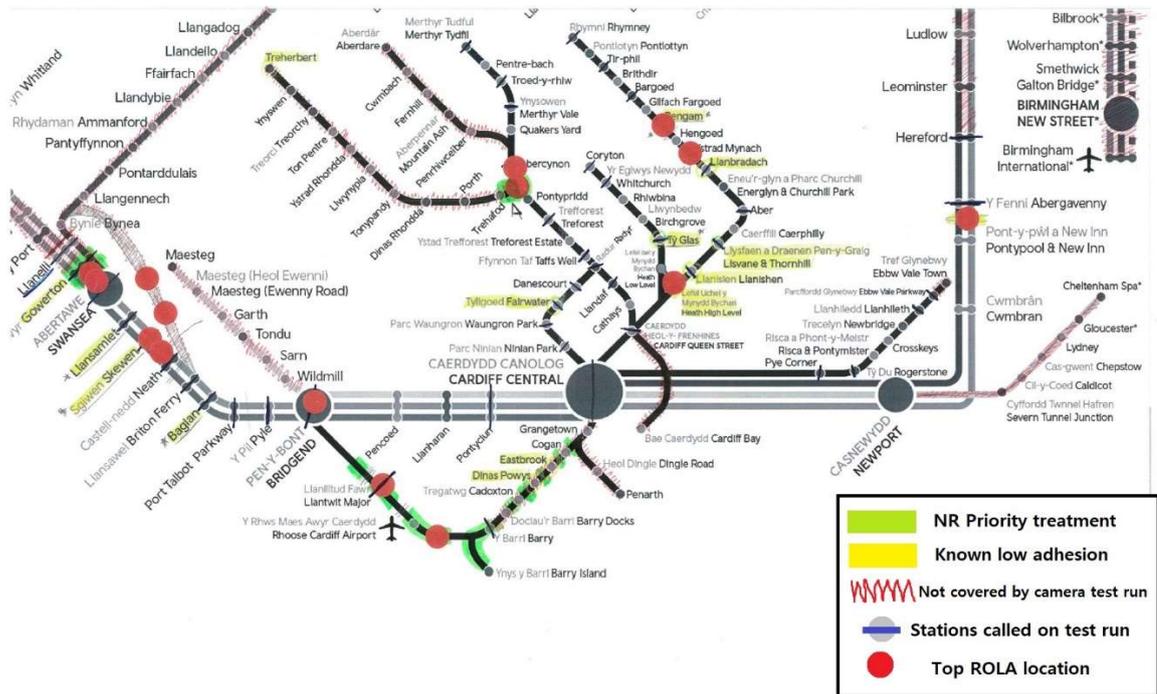
Fig. 1: Map of camera test run routes, showing sites with low adhesion and priority de-vegetation.

- Wheel-rail interface video covered a large proportion of South Wales. This also captured a wheel slide incident resulting in a minor wheel flat.
- The following factors were also revealed by the footage:
 - Presence of low-level vegetation near the rails.
 - Evidence of some fluid splashing on to the interface
 - Litter/debris close to rail
 - Some litter /vegetation migration on to the interface.
 - Presence of dust at the interface, potentially brake block or other external sources.

A video commentary document has fully noted the above events, cross referenced with GPS location.
